# DOWN HOUSE, BROMLEY

*Notes on the Baize Door (GD19), Between the  
Hall (G11) and the Servants' Area (G10)*

Richard Lea

Historical Analysis & Research Team  
*Reports and Papers (First Series, 32)*  
(1997)

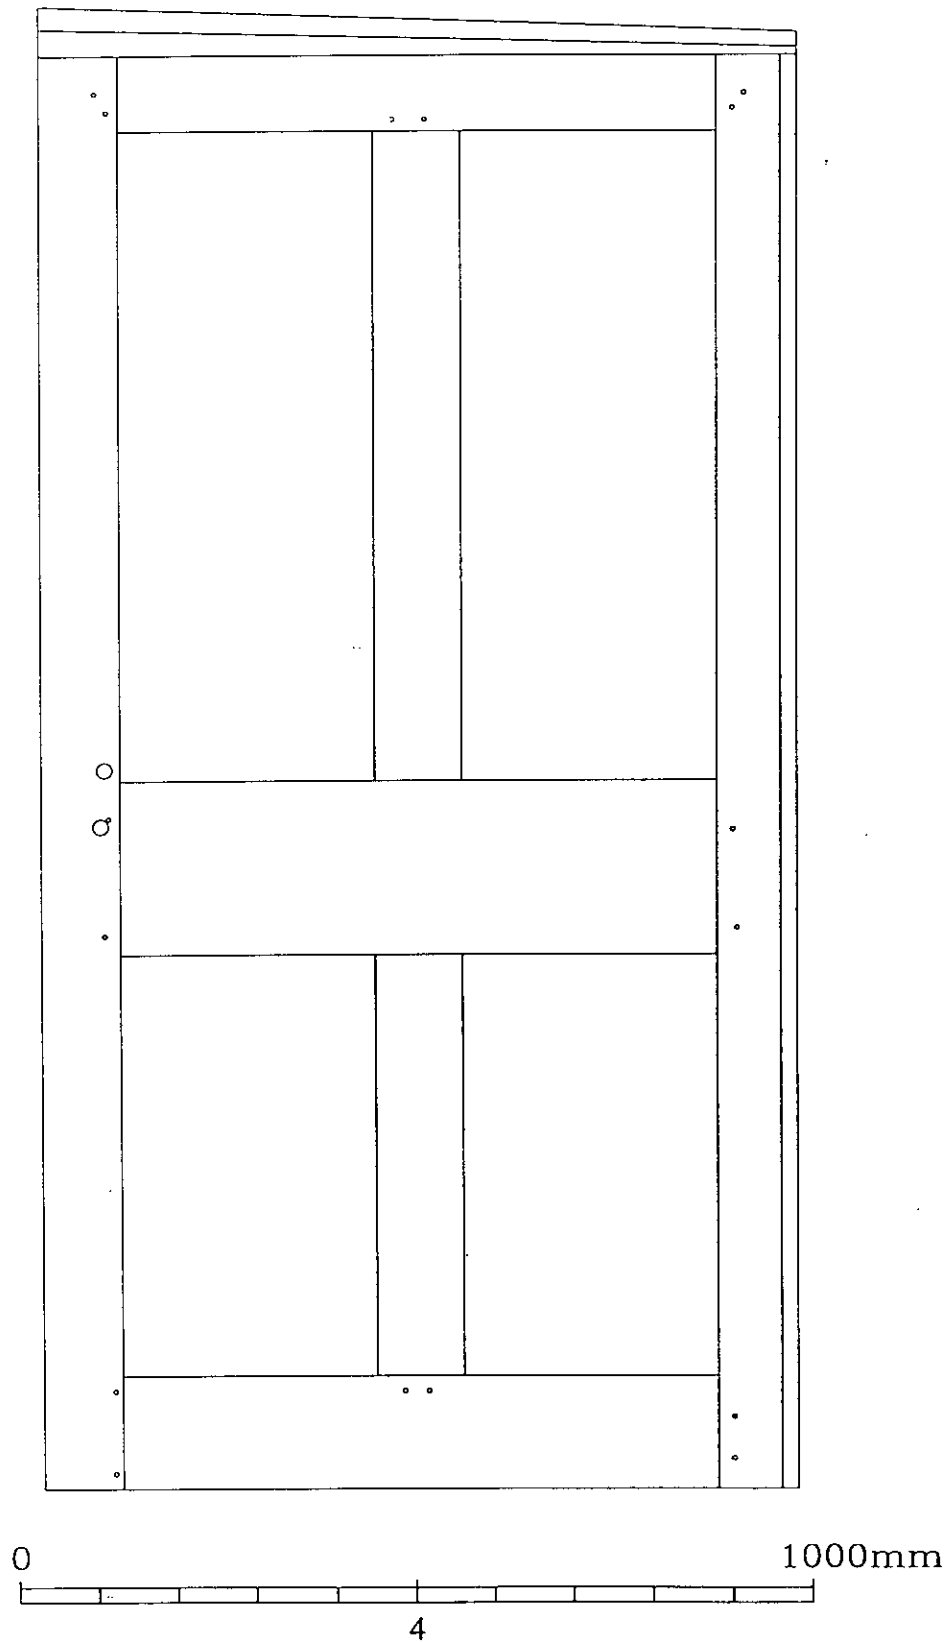
In recent years the door was covered with hardboard. In the current restoration works, the hardboard was removed and a fire proofing panel has been attached to the south side of the door. Its construction as a flat four panel door of uniform thickness, indicates that it was designed to be covered in fabric, Figure 1. There are no traces of paint on the flat sides of the door, only on the edges and around the margins indicating that it has always been covered with a fabric, hardboard or some such material. It has been widened by the addition of a fillet on its west (hinge) side and heightened, apparently twice, apparently to compensate for movement in the doorframe. The actual door-leaf itself does not appear to be distorted.

**Figure 1** Elevation of the north side of the baize door, showing the panel construction, pegged joints, additional fillets to top and side and holes for door-handles

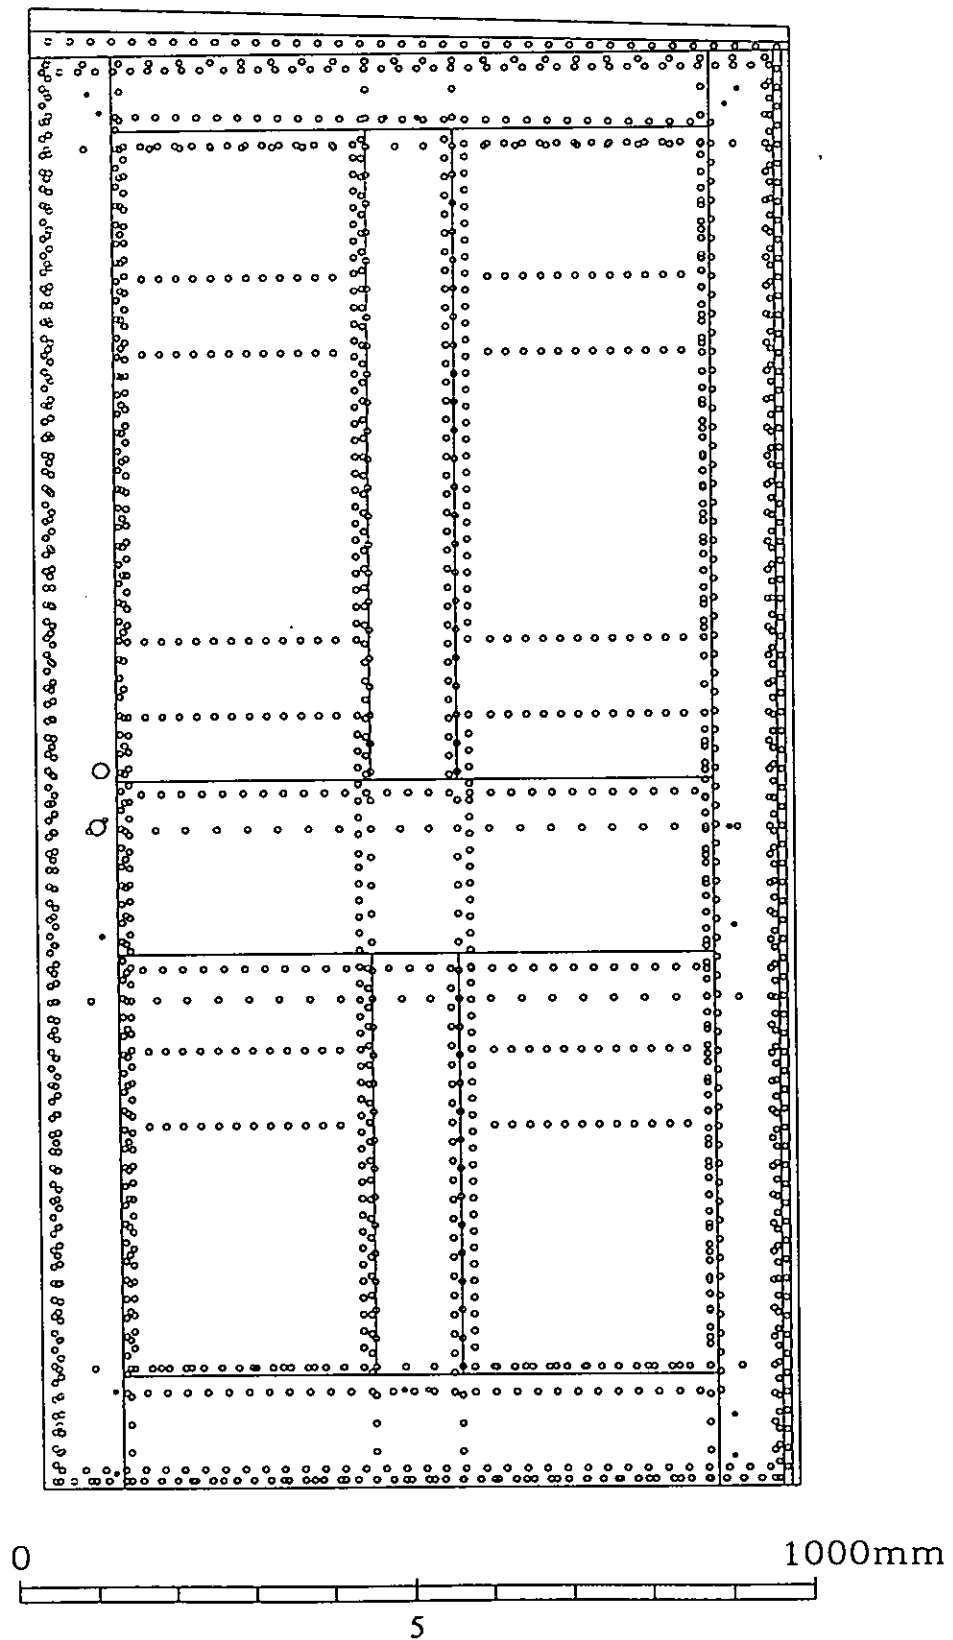
On the north side of the door, several patterns of nail holes were visible which relate to different forms of panel door construction. None of the nails remained *in-situ*. The holes presumably derive from the fixing of the baize fabric. There were so many holes, I did not attempt to draw them individually. I did however try to pick out lines of nails which I could relate to the different patterns. Taken together, the overall picture is quite confusing, Figure 2, but I have managed to identify three distinct patterns which appear to relate to different phases, Figures 3-5.

Furthermore, there were many more nail holes than shown even in Figure 2. This suggests either that some of the patterns were repeated when the fabric was repaired or that the actual method of fixing required more than just the cup headed tacks. It is possible that an additional strip of cloth or braid was used, either functionally or decoratively, to emphasise the lines picked out by the nails and further simulate the effect of panelling.

The spacing between the implied nails varied from pattern to pattern, Figure 2. In the pattern shown in Figure 3, the spacing between the cup-headed nails appears to have been *c* 22mm, for that in Figure 4, a spacing of *c* 38mm, and for that in Figure 5, *c* 25mm.

**Figure 2** Elevation of the north side of the baize door, showing in schematic form the distribution of nail holes relating to the fixing of the baize

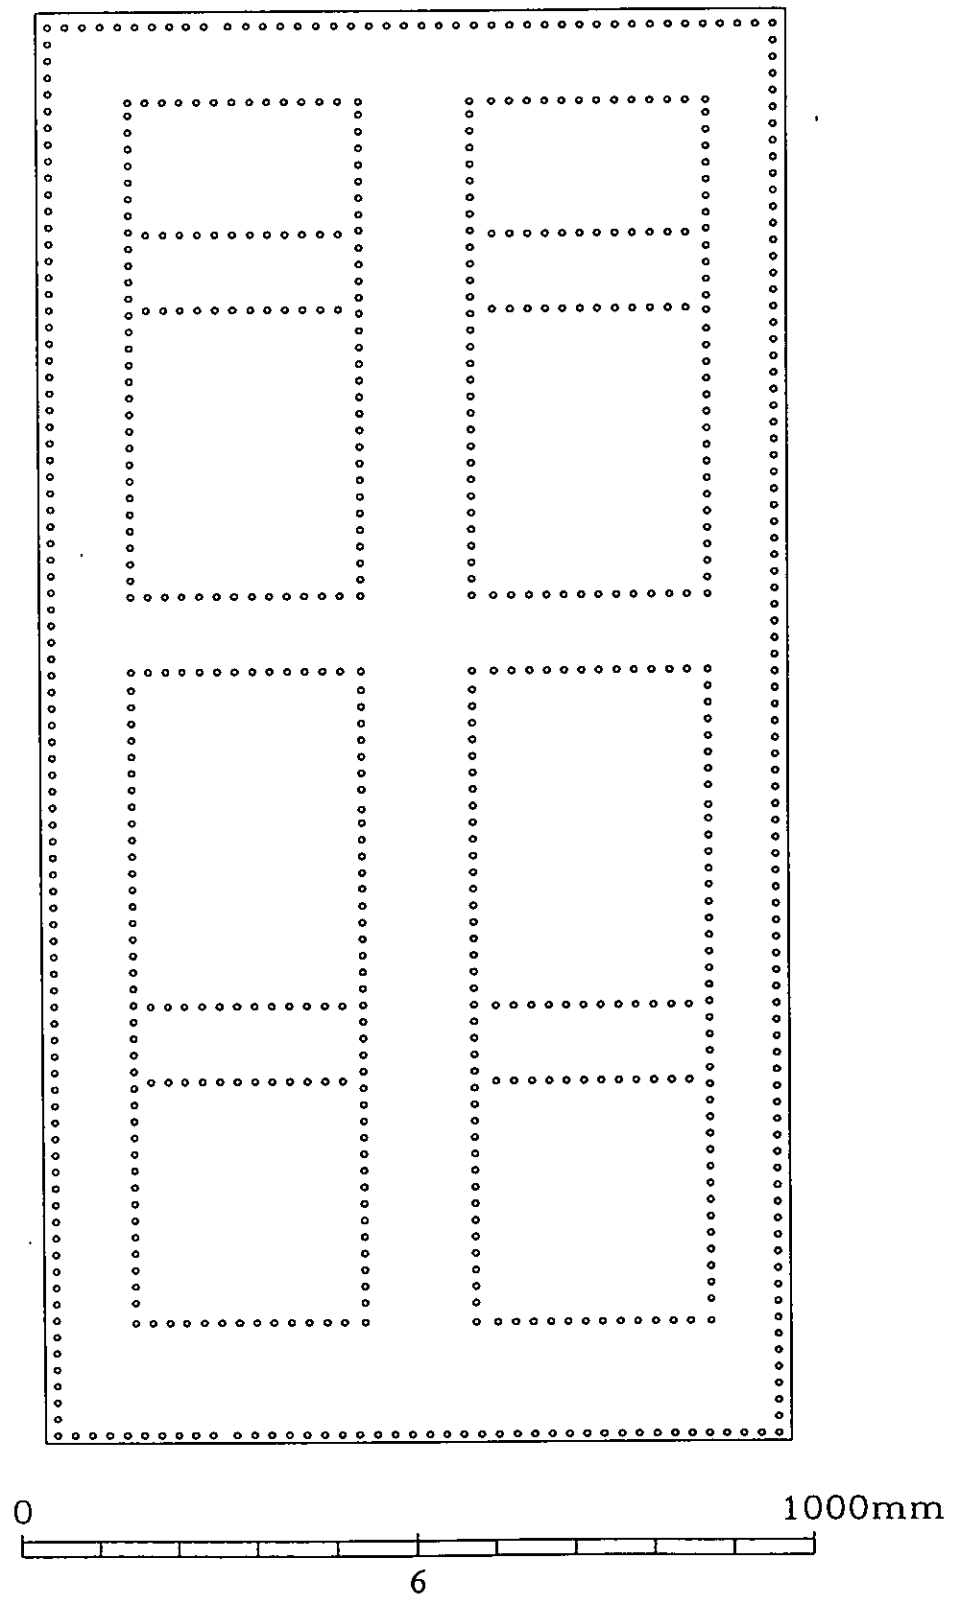
The patterns shown in Figures 3 and 4 both appear to relate to the original shape of the door, not modified by the addition of fillets.

The eight panel design, Figure 3, relates, although not exactly, to the adjacent eight panel doors to the Old Study, G15, Dining Room, G2, and closet under the stairs G3 and G4. The proportioning of the panels appears slightly odd, the mid-rail is rather high.

**Figure 3** Elevation of the north side of the baize door, showing a pattern of nail holes which suggests an eight panel door design

The two patterns shown in Figures 3 and 4 probably date from Darwin's residency at the house. Of the two, Figure 3 seems to me to be the more considered architecturally since it relates to the adjacent doors. I would therefore suggest that this pattern is adopted in the restoration. It will require some slight modification, since the door has been enlarged to fit the distorted door frame but this should not present too great an obstacle.

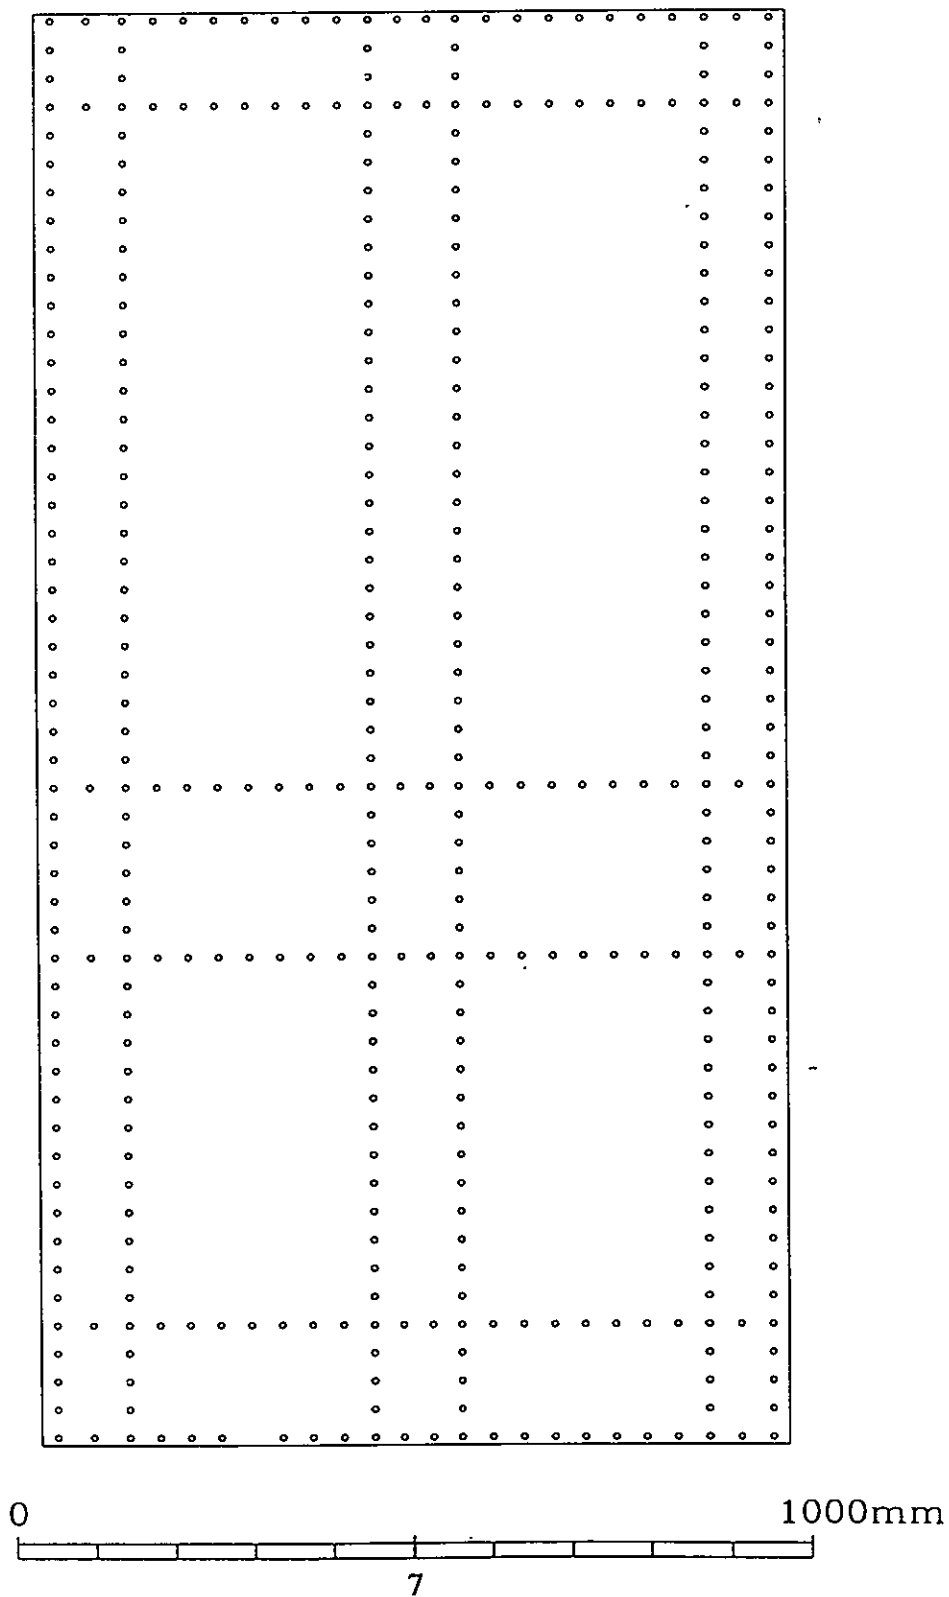
The pattern shown in Figure 4 is based on a typical four panel design but all horizontal vertical lines are unbroken, as it were without respect for the implied joinery pattern.

**Figure 4** Elevation of the north side of the baize door, showing a pattern of nails which relates to a four panel door design

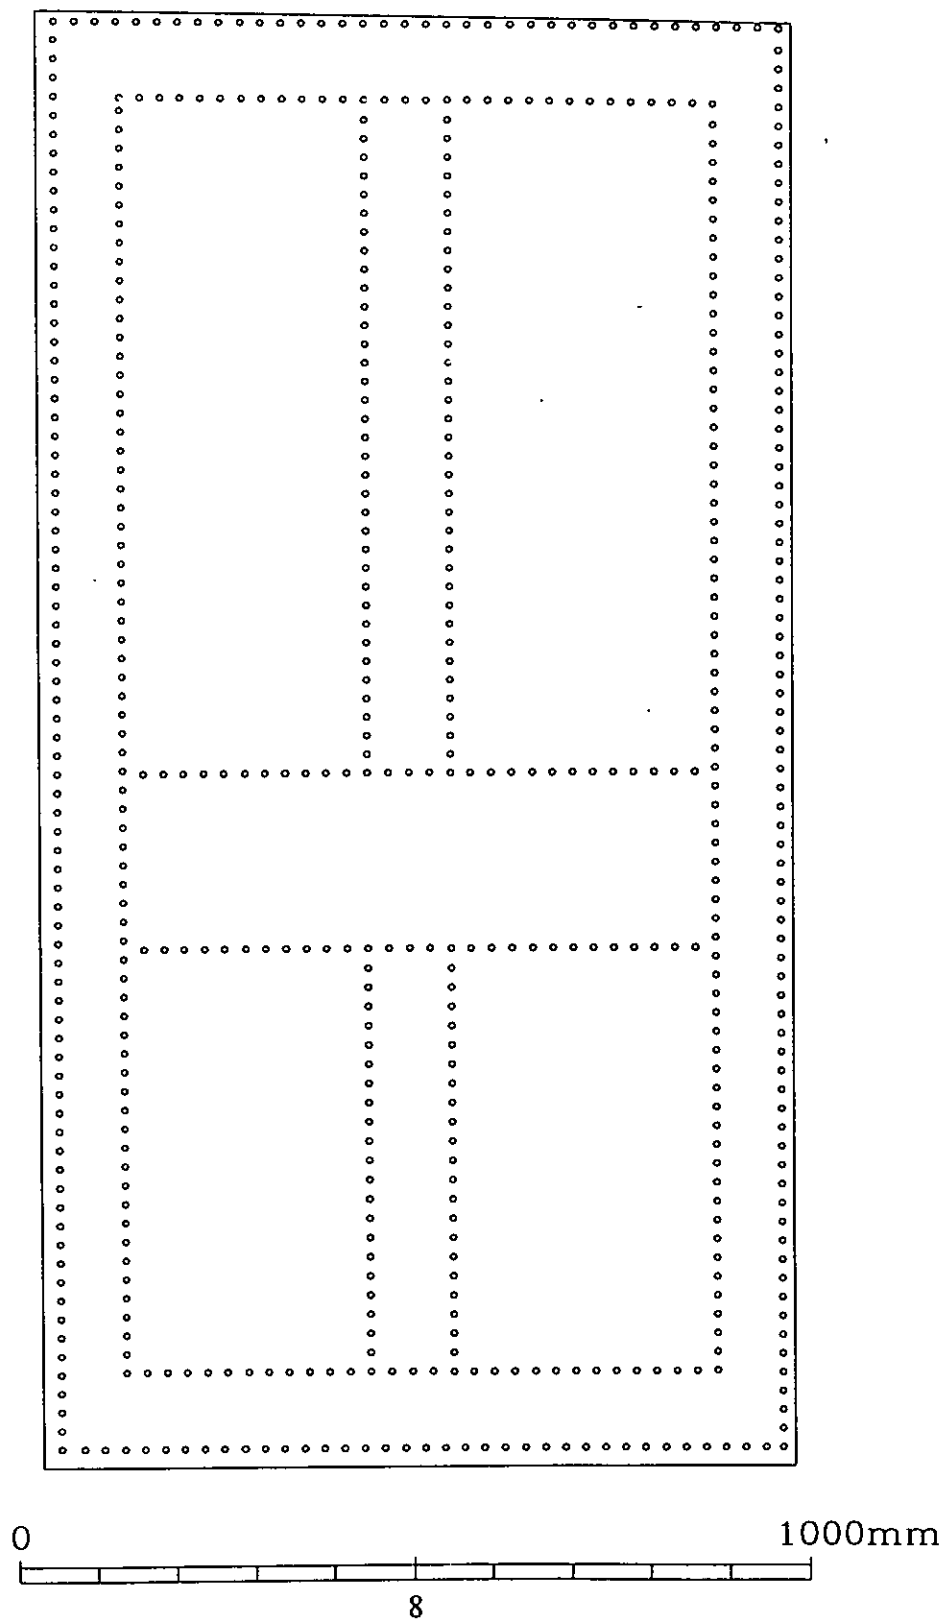
The pattern shown in Figure 5 appears to post date the addition of the fillet to the side and the first one to the top of the door. This pattern therefore appears to be relatively modern.

**Figure 5** Elevation of the north side of the baize door, showing a pattern of nails relating to a four panel door design, apparently applied after the door was enlarged
