# DOWN HOUSE, BROMLEY

*Notes on the Original Heating System Installed in  
Darwin's Greenhouse*

Notes on the original heating system installed in  
Darwin's greenhouse

25 January 1999

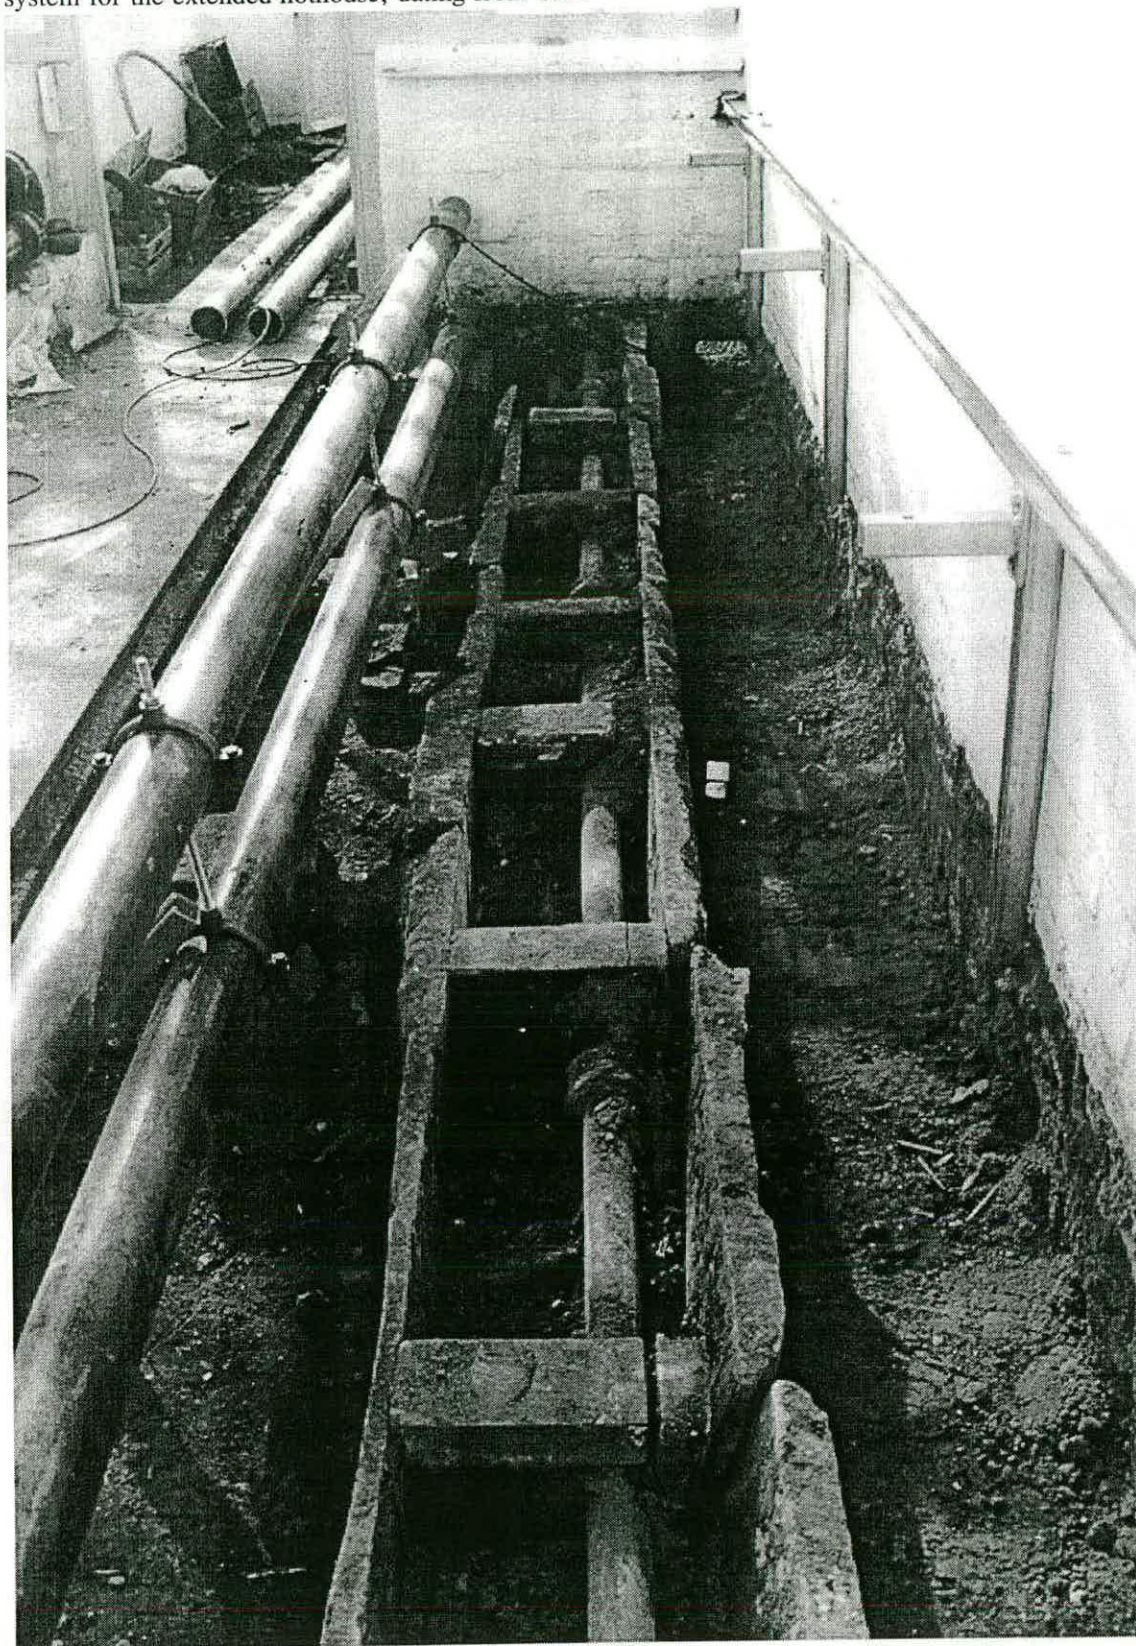
**Figure 14** The channel on the north side of the hothouse for the 2" pipes, part of the heating system for the extended hothouse, dating from 1864

On the north side of the hothouse and in the eastern greenhouse, 2" pipes were set below floor level in a channel formed by reused floor slabs set on edge. The pipes were supported within the channel by cross walls of brick set at intervals of approximately 900mm. There were no traces of the original covering of this channel. It might have been covered either with an iron grille or with floor flags. The absence of any evidence for an iron frame, however, suggests that stone is more likely than iron.

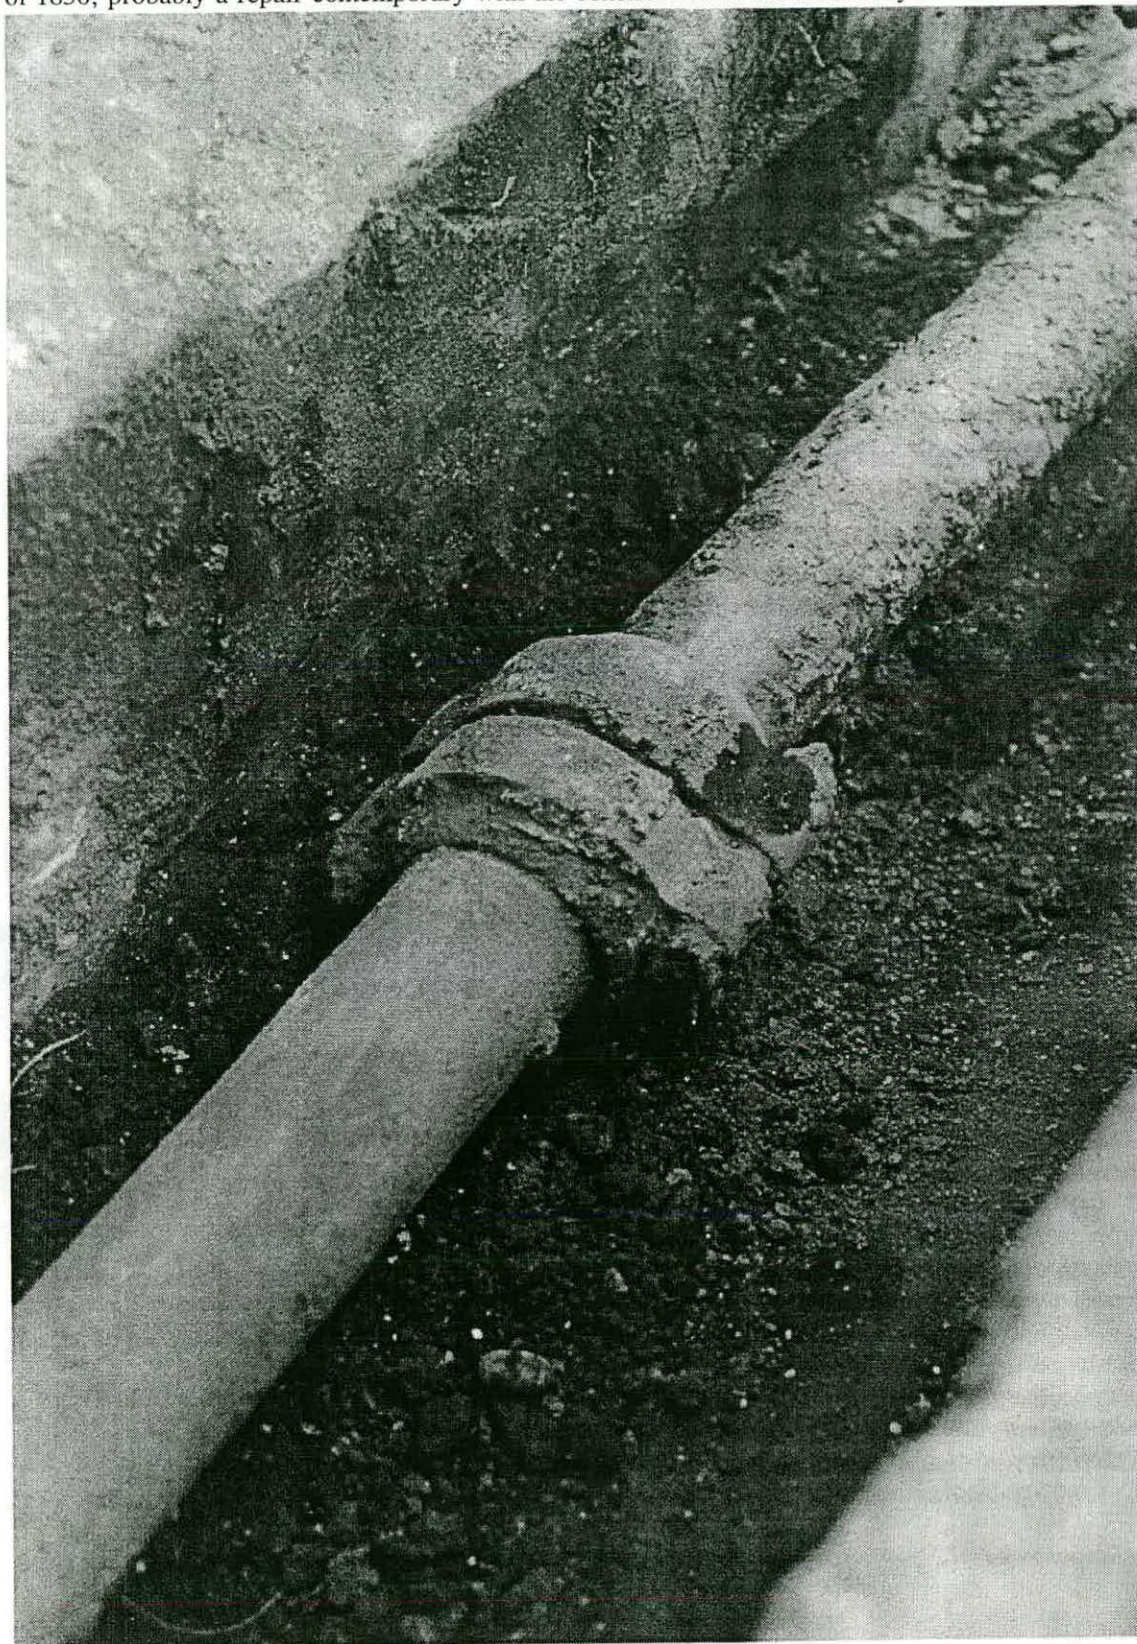
**Figure 20** A bolted joint in the 2" pipes in the channel on the north side of the first greenhouse of 1856, probably a repair contemporary with the construction of the laboratory in 1881

In the eastern section of the greenhouse, the original return pipe appears to have been altered or repaired using bolted joint types sealed with bitumen which belong to this phase.
